Rail Accident: Case Study

Signal post collapse caused by corrosion damage

UK's Rail Accident
Investigation Branch (RAIB)

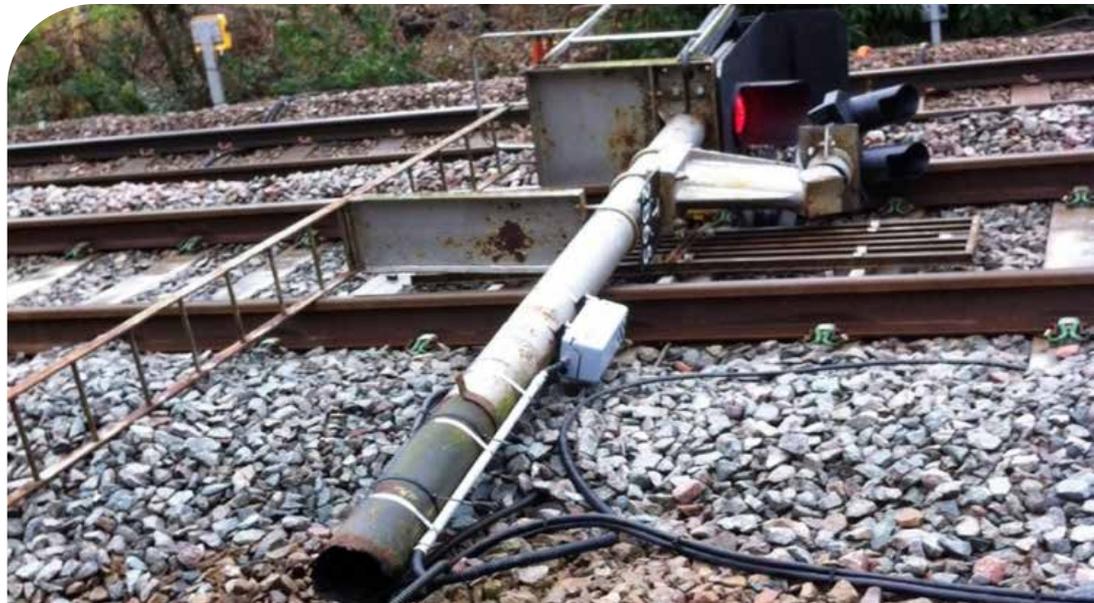
The fallen signal post after the accident - image from official RAIB report, supplied by Network Rail.

The RAIB concluded that the signal collapsed because the base of the post had corroded.

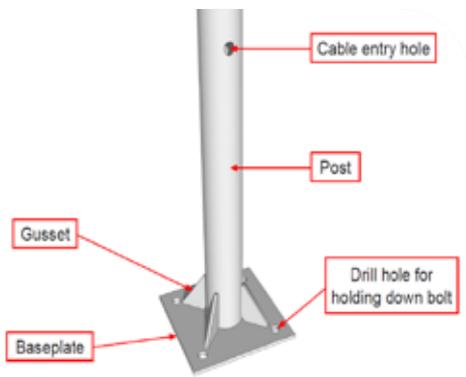
- Traces of a coating system were detected, most likely to have been originally applied to prevent atmospheric corrosion. Very little of this was found remaining on the corroded section of the post.
- Corrosion was focused at ground-level. Ballast and holding water concentrated around this area were likely to have affected the integrity of the coating system originally applied and increased the posts' susceptibility to corrosion.
- Rainwater was able to seep through the open top of the post. As no drainage system was implemented, it was able to pool internally at the bottom.
- The bottom section of the post critically affected by corrosion was buried in ballast and the visible section (above ground level) remained relatively unaffected. This may explain why the damage was not detected by routine visual examinations.

Schematic of post and baseplate - image from official RAIB report

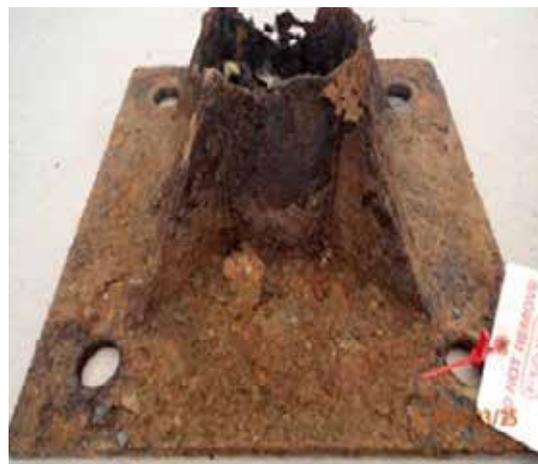
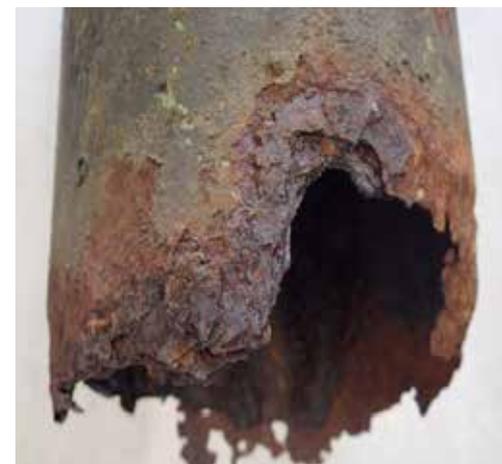
- Both internal and external corrosion had occurred around the base of the post,

resulting in severe metal wastage.

Close-up of corrosion damage at the base of the signal post - Intertek was commissioned to understand the failure mechanism, the progression of corrosion in the post and the nature of the post material.

- The asset management strategy should be reviewed in order to improve examination and maintenance processes.
- A risk assessment process should be developed and implemented that specifically addresses partially buried hollow ancillary structures and their susceptibility to corrosion.
- Examination maintenance regimes for ancillary structures should be reviewed and an additional five key steps added. These were developed following the Newbury post incident and were designed to consider aspects that may have been overlooked previously and enabled the corrosion of the hollow post to go undetected.
- Competence management processes for personnel involved in structure examinations should be reviewed and revised.

Network Rail has since assessed 1,754 signal posts and installed ballast boards to mitigate similar issues where necessary.

In addition, Network Rail commissioned a retrofit design to strengthen weakened assets.
