CORROSION CAUSES RAIL ACCIDENT

Corrosion damage causes signal post to collapse

A Railway Company

Intertek Solutions

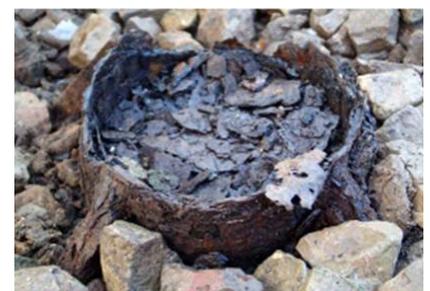
- Corrosion was focused at ground-level. Ballast and holding water concentrated around this area were likely to have affected the integrity of the coating system originally applied and increased the posts’ susceptibility to corrosion.
- Rainwater was able to seep through the open top of the post. As no drainage system was implemented, it was able to pool internally at the bottom.
- The bottom section of the post critically affected by corrosion was buried in ballast (seen below) and the visible section (above ground level) remained relatively unaffected. This may explain why the damage was not detected by routine visual examinations.

Hidden corrosion damage of the baseplate

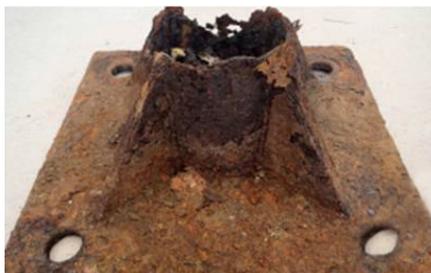
Corrosion damage of the baseplate

The RAIB concluded that the signal collapsed because the base of the post had corroded. It also found that the corrosion was not detected by the routine examination regime, by additional inspections carried out during a resignalling project or during maintenance. The RAIB made several recommendations in its report to prevent a similar incident happening again in the future.

- The asset management strategy should be reviewed in order to improve examination and maintenance processes.
- A risk assessment process should be developed and implemented that specifically addresses partially buried hollow ancillary structures and their susceptibility to corrosion.
- Examination maintenance regimes for ancillary structures should be reviewed and an additional five key steps added. These were developed following this signal post collapse incident and were designed to consider aspects that may have been overlooked previously and enabled the corrosion of the hollow post to go undetected.
- Competence management processes for personnel involved in structure examinations should be reviewed and revised.

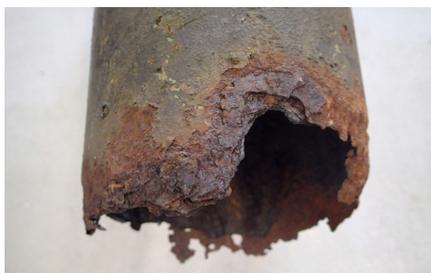
Corrosion damage at the base of the signal post
