Case Study:

Cracked Oil Tanks Investigations

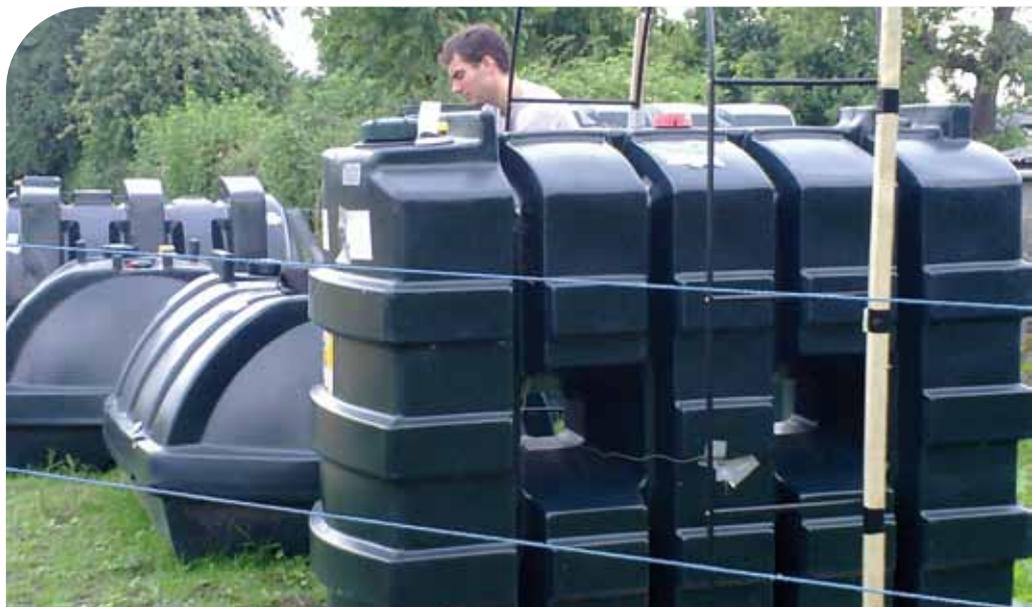
Tanks undergoing testing

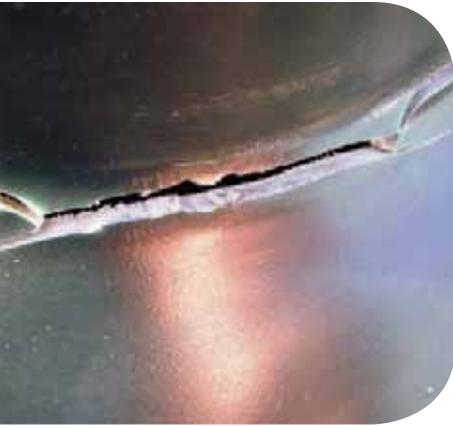
Crack at corner of a tank

Both the oil tank manufacturers' claims against Borealis failed in their entirety. The Court, on both occasions, found that the oil tank failures were not due to any problems with the Borealis polymer material, but essentially were due to a combination of factors including:

- Tank design
- Failure to optimise processing
- Tank wall thickness/thinness variations
- Quality control procedures

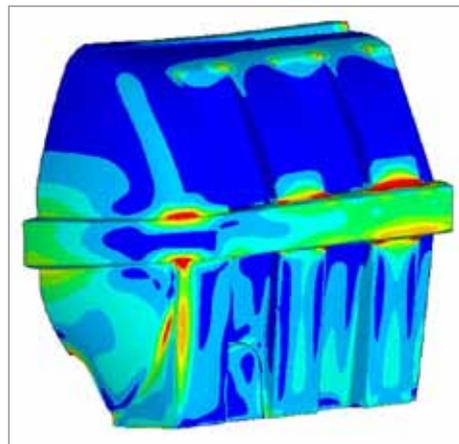
Stress analysis (FEA model) of a tank

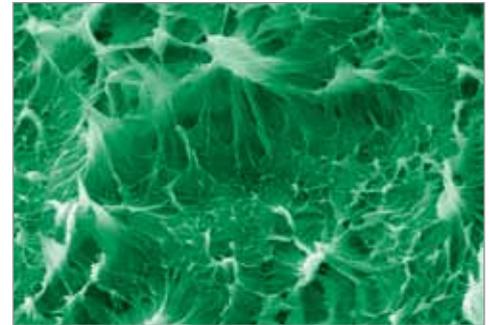
Scanning electron microscope (SEM) image
